**NUMBER:** 23-059-17

Noise From the Rear Shelf Panel

This bulletin involves installing a seal on the rear shelf panel.

2015 - 2017 (LA) Dodge Challenger

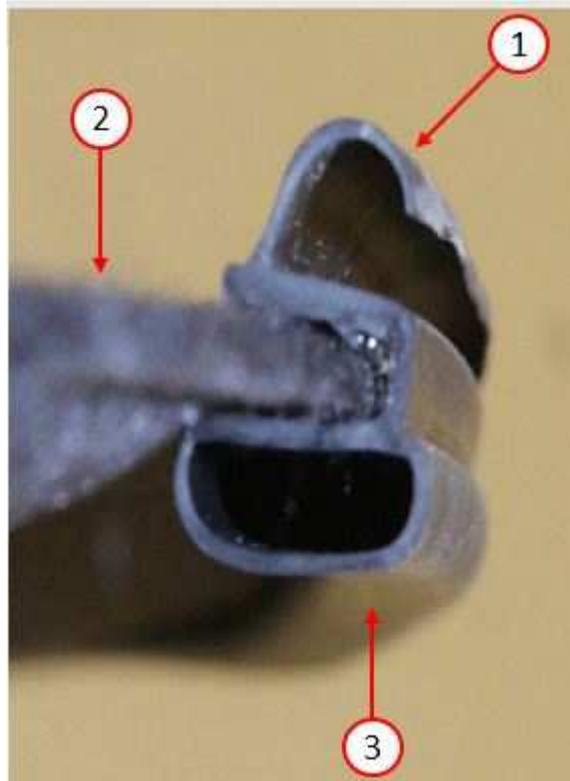
**Fig. 2**  
**Seal Installed on Rear Shelf Panel**

- 1 - Top of the Seal Facing Rear Glass
  - 2 - Top of the Rear Shelf Panel
  - 3 - Bottom of the Seal Facing Package Shelf Support
-

3. Install the seal on the rear shelf panel, with the top of the seal facing upward, see (Fig. 2) .

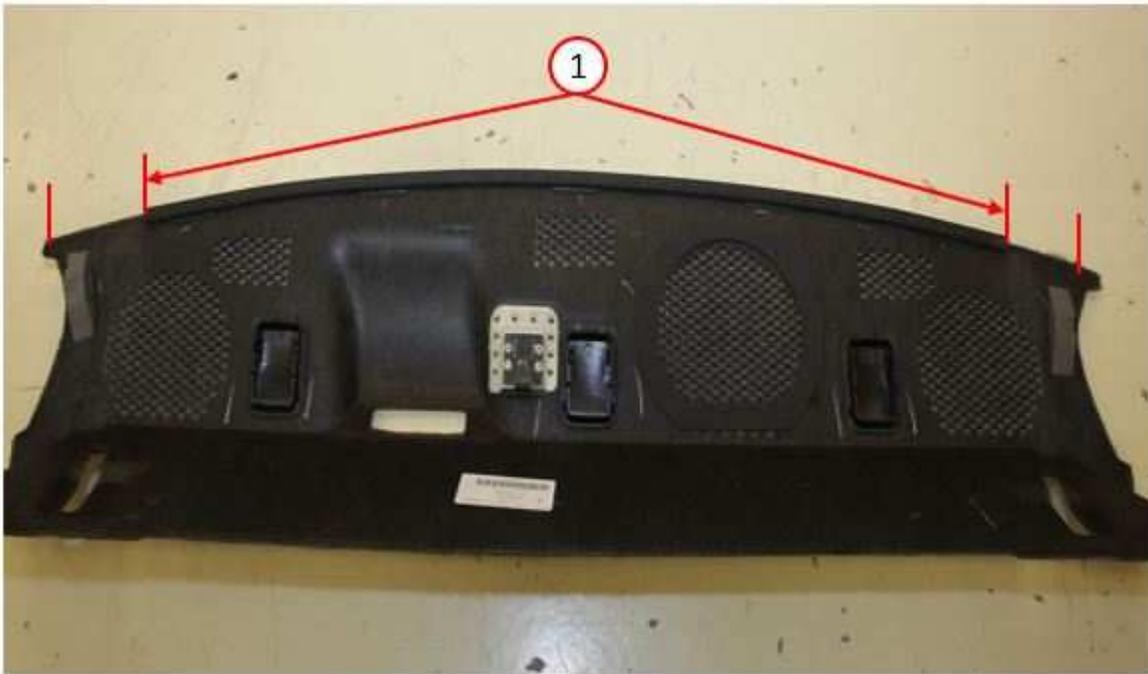
**Fig. 3**  
**Seal Location on Rear Shelf Panel**

1 - End Of the Seal

- The seal is **Not** the same length as the rear shelf panel. Center the seal on the panel so there are equal gaps at each side of the panel, see (Fig. 3.)

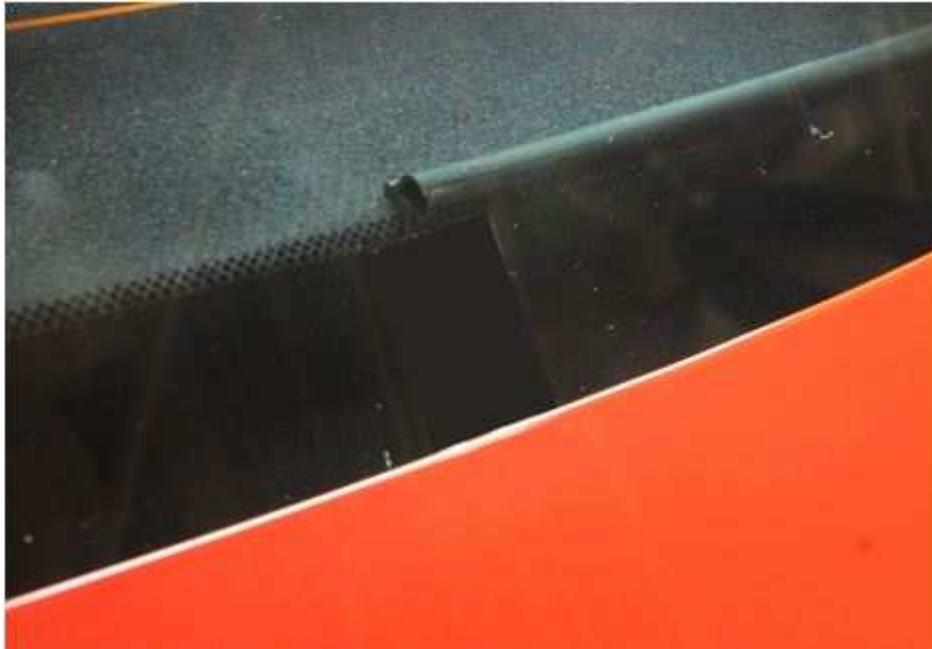
**Fig. 4**  
**End of the New Seal**

**NOTE:** When looking into the vehicle from the rear glass, there will be a noticeable gap at each end of the seal, this is normal, see (Fig. 4) .
